Cape Cod Hospital Parking Deck · Hyannis, Massachusetts · 14,500 SF Neogard Auto-Gard FC traffic-bearing waterproofing

# Stopping the Leak Into the ER — and Ending Years of Crack Repair Cycles

Cape Cod Hospital, Hyannis MA · Owner: **Cape Cod Healthcare** · Completed May 2025

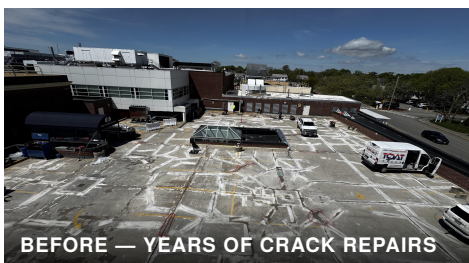
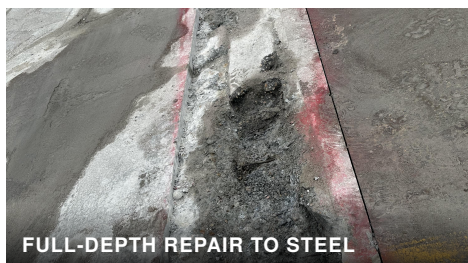
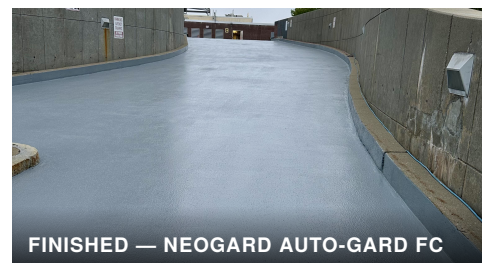
## BEFORE · DURING · AFTER

Cape Cod Hospital's parking deck had reached the end of its serviceable life. Water was migrating through cracks and joints and reaching the Emergency Department below. Facilities had been managing the deck for years through ongoing crack repair and re-caulking cycles — labor-intensive, costly, and never resolving the underlying waterproofing failure. Full deck shutdown was required to fix it correctly.

Contracted directly with Cape Cod Healthcare. We shut the deck down, executed full-depth concrete repairs back to the metal decking where required, used a Von Arx DTF 35 shaver to remove existing coatings and surface contaminants, sealed every crack and joint with Sika 2C NS, and installed the full Neogard Auto-Gard FC traffic-bearing system: 70700/70701 primer, 7500 base coat, and two coats of 7510/7961 with integral aggregate for slip resistance and long-term wear.

- 1 Deck Shutdown.** Coordinated with Cape Cod Healthcare facilities to fully close the deck and stage the work.
- 2 Surface Prep.** Von Arx DTF 35 shaver removed existing coatings and contaminants down to sound concrete.
- 3 Concrete Repairs.** Full-depth removal back to the metal decking; structural reinstatement to grade.
- 4 Crack & Joint Sealing.** Routed and sealed cracks and joints with Sika 2C NS.
- 5 Primer.** Neogard 70700/70701 applied across full deck and ramps.
- 6 Base Coat.** Neogard 7500 elastomeric base — primary waterproofing layer with crack-bridging.
- 7 Top Coats.** Two coats of Neogard 7510/7961 with integral aggregate broadcast for slip resistance.
- 8 Restripe & Turnover.** Stalls and ADA markings reinstated; deck returned to service.
