# Why Floor Coatings Fail

## Whether peeling, bubbling or delamination needs more investigation

By **Henry Hunt**, Partner, Topcoat Services USA · For owners, facility managers, contractors and specifiers

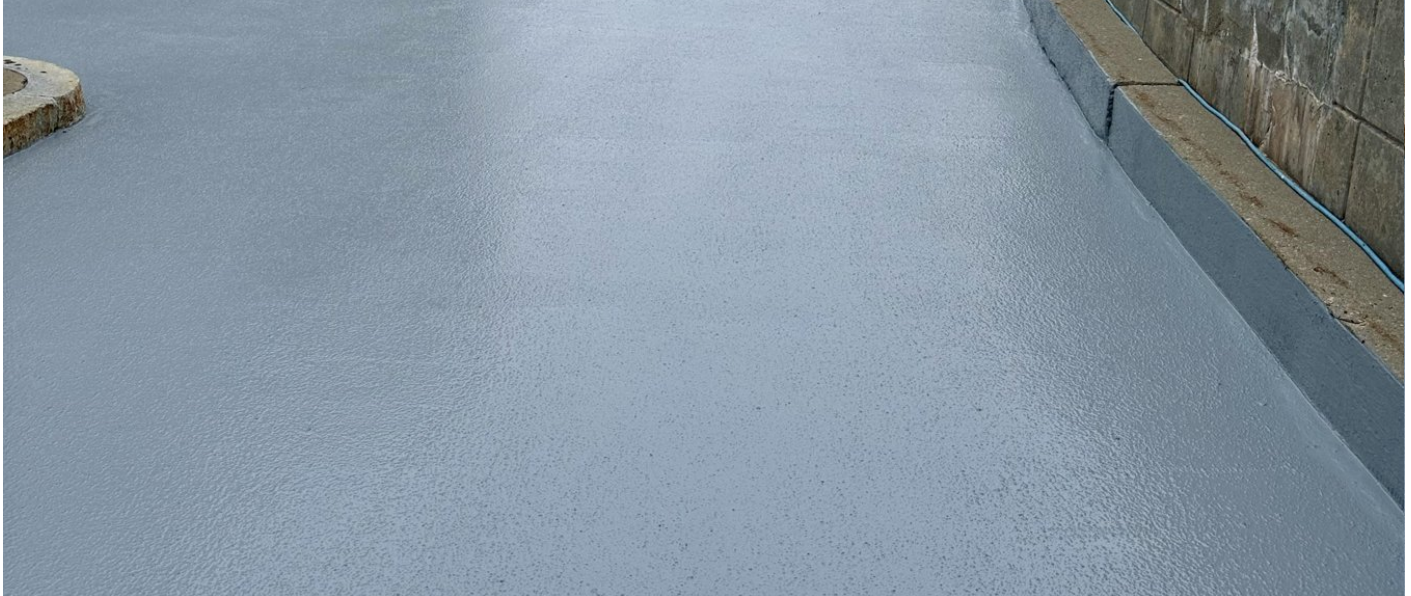
*Polyurethane traffic coating on a vehicular ramp.*

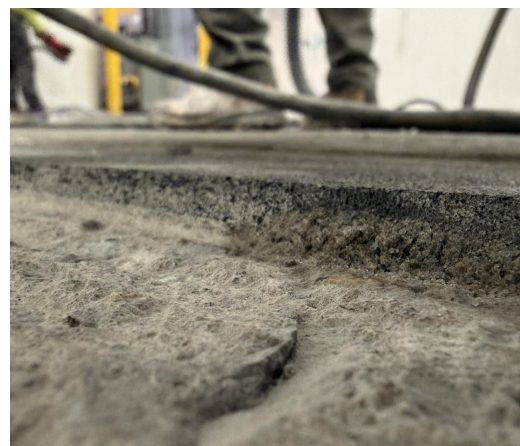
*Mechanical removal and prep down to sound concrete.*

When bond loss is widespread, full removal is often the most reliable answer, but testing should confirm the extent first. Sometimes sound areas can stay. We removed about 27,000 lbs of failed epoxy mortar from a food manufacturing room after repairs had been chasing the problem for a while, and replaced it with a urethane-based system.
